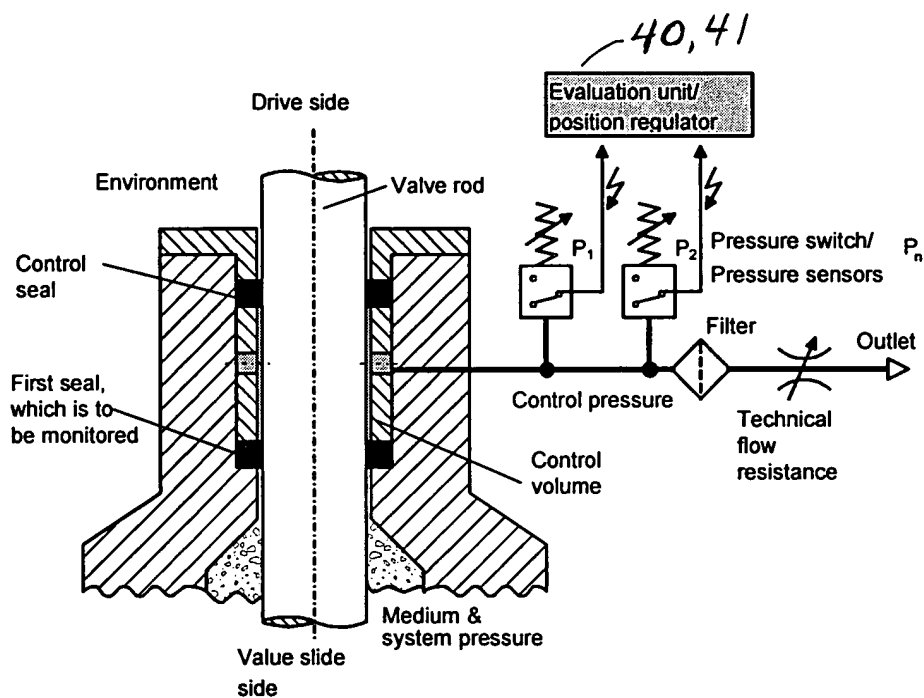
Figure 2: Continuous monitoring of a seal by observing the control pressure, in this case, by way of example, by means of two pressure switches

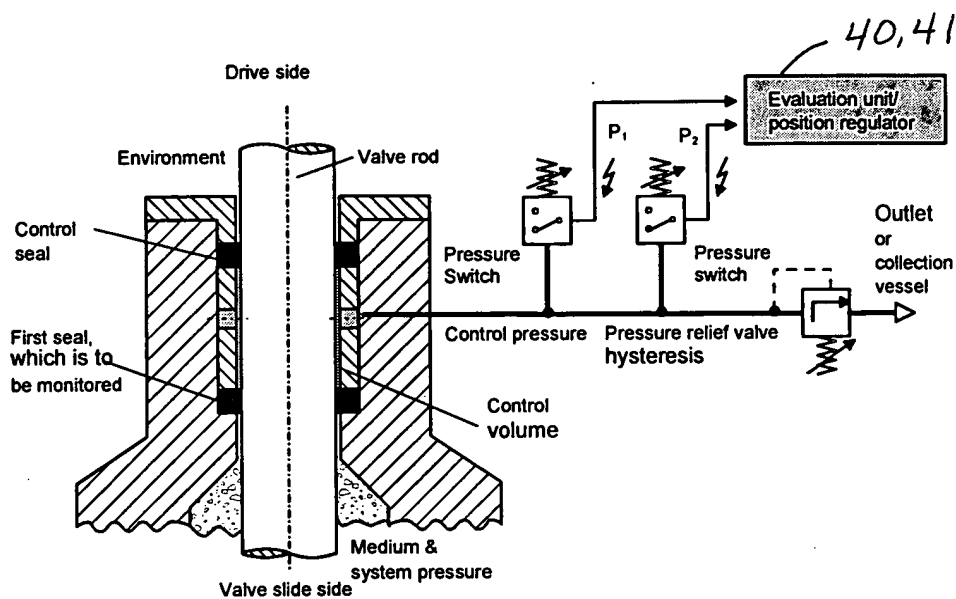
Figure 3: Monitoring of a seal by observing the control pressure, venting from time to time via a pressure relief valve with hysteresis

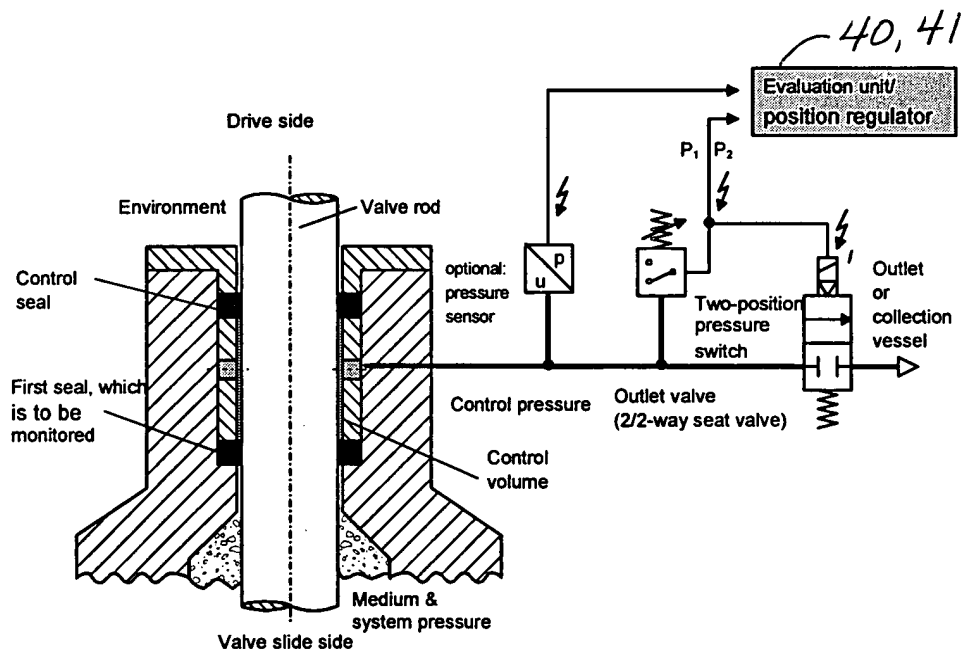
Figure 4: Monitoring of a seal by observing the control pressure, venting from time to time via a 2/2-way switching valve of the "normally closed" type, driving for example by means of two-position pressure switch

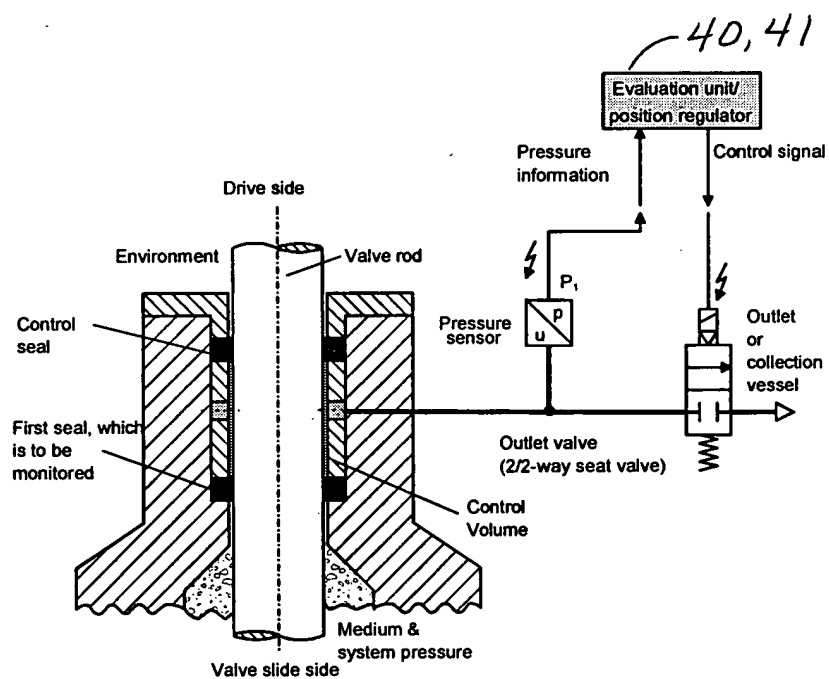
Figure 5: Monitoring of a seal by observing the control pressure, venting from time to time via a 2/2-way switching valve of the "normally closed" type, driving via evaluation unit
